# Manhole Inspection Summary

Manhole # S33Q\_\_011MH

Insp Date: **3/14/08 10:58 AM**

**Location** Address: **139 hamburg**

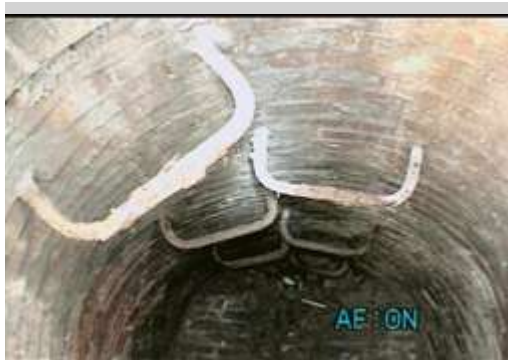
Defect 2

Count: **6** Missing: **0** ☒ **Corroded**

corroded steps

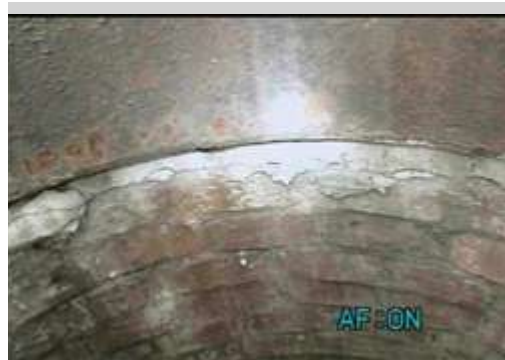
Defect 1

Condition: ☐ Sound ☒ **Cracked** ☐ Root Intrusion ☐ Loose Brick ☐ Deteriorated

chimney is cracked, frame adjustment

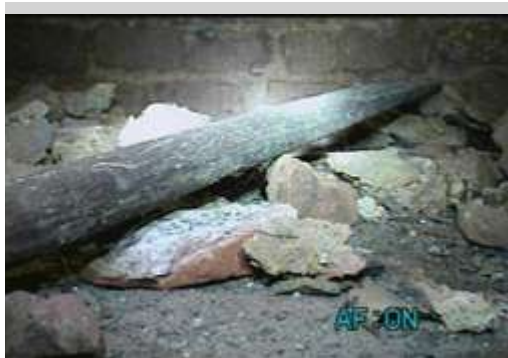
Defect 3

Condition: ☐ Sound ☐ Cracked ☐ Root Intrusion ☐ Deteriorated ☐ Leaks ☒ **Debris**

channel debris
